**Flood Control Project Maintenance
Levee Inspections**

Fall 2009 Levee Maintenance Deficiency Summary Report

Reclamation District No. 2058 Pescadero

Waterway			Bank	Unit Miles
Unit No. 01 Paradise Cut			Left	6.71
	Spring (March - May)	Summer (June - August)	(September - November) Fall	Winter (December - February)
Unit Maintenance Rating (Fall Only)			U	
Date of Inspection	4/20/2009		10/6/2009	
DWR Inspector	Richard Willoughby		John Paasch	
Accompanied By

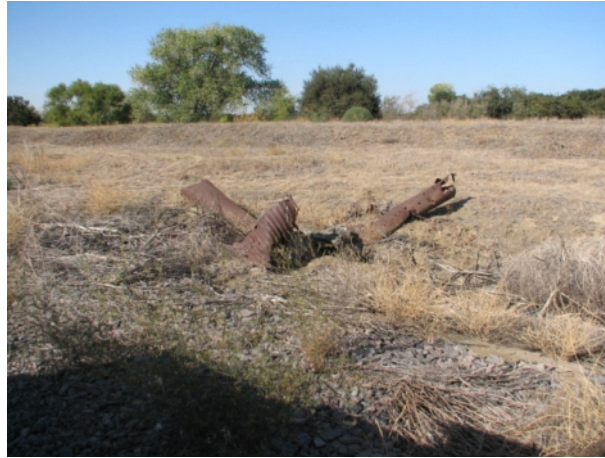
Levee Mile Report Line	2
Start Levee Mile	0.05
End Levee Mile	0.05
Location	Water Side
Category	Earthen Levee
Item	Encroachments

Photo of trash.

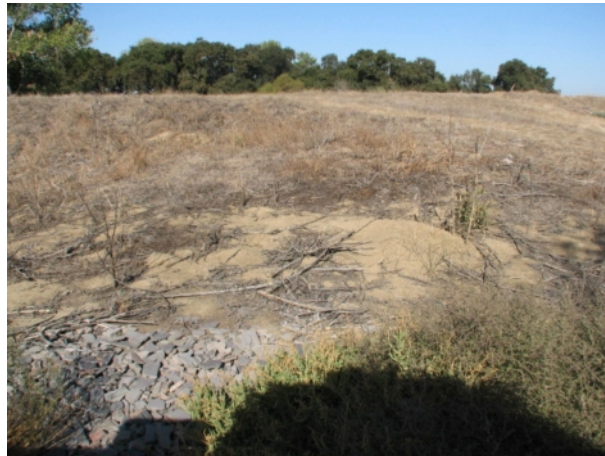
Levee Mile Report Line	3
Start Levee Mile	0.12
End Levee Mile	0.12
Location	Water Side
Category	Earthen Levee
Item	Animal Control

Photo of burrow hole on water side.

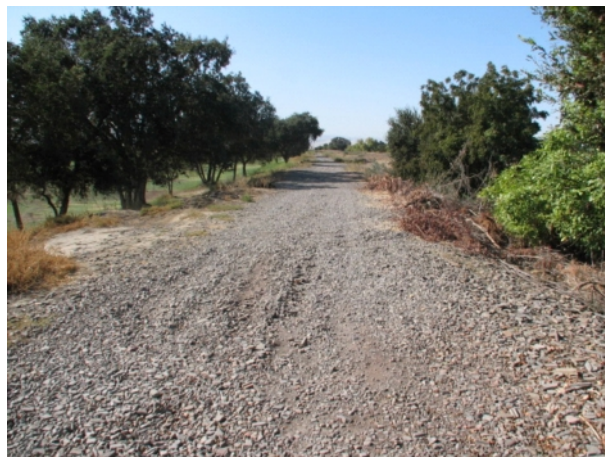
Levee Mile Report Line	4
Start Levee Mile	0.15
End Levee Mile	0.18
Location	Water Side
Category	Earthen Levee
Item	Encroachments

Photo of tree prunings on levee hinge point.

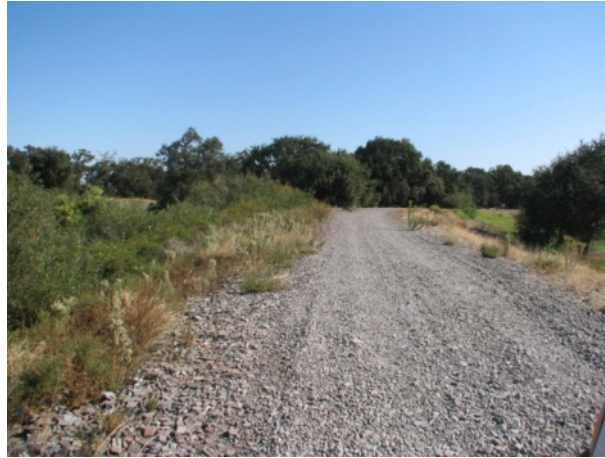
Levee Mile Report Line	7
Start Levee Mile	0.27
End Levee Mile	0.29
Location	Water Side
Category	Earthen Levee
Item	Trim / Thin Trees

Photo of trees and thick brush on water side slope of levee.

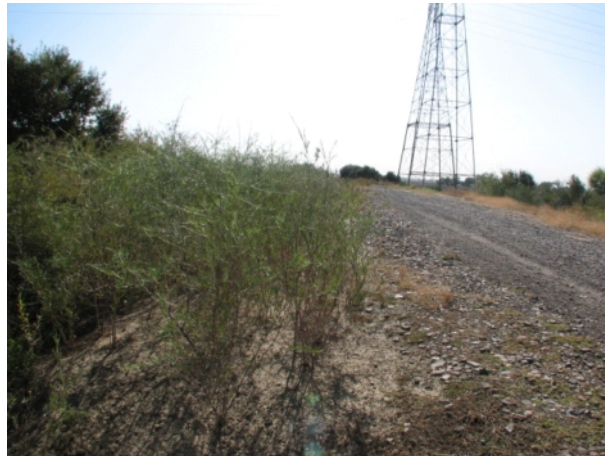
Levee Mile Report Line	8
Start Levee Mile	0.41
End Levee Mile	0.43
Location	Water Side
Category	Earthen Levee
Item	Vegetation

Brush near crown on waterside slope.

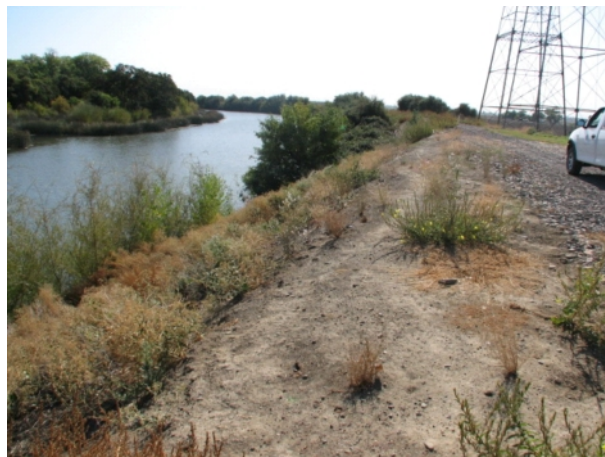
Levee Mile Report Line	9
Start Levee Mile	0.43
End Levee Mile	0.46
Location	Water Side
Category	Earthen Levee
Item	Vegetation

Maintained water side slope.

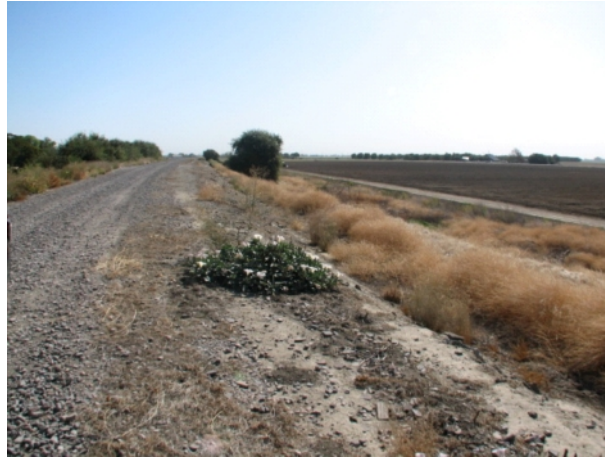
Levee Mile Report Line	12
Start Levee Mile	0.50
End Levee Mile	0.71
Location	Land Side
Category	Earthen Levee
Item	Vegetation

Photo of vegetation on landside slope and toe.

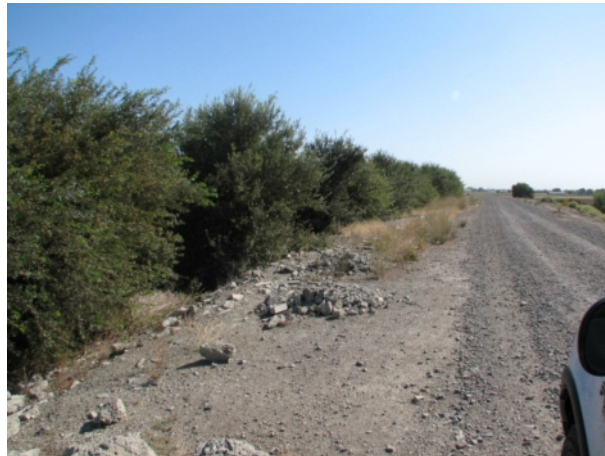
Levee Mile Report Line	16
Start Levee Mile	0.82
End Levee Mile	0.93
Location	Water Side
Category	Earthen Levee
Item	Trim / Thin Trees

Photo of dense trees on waterside slope.

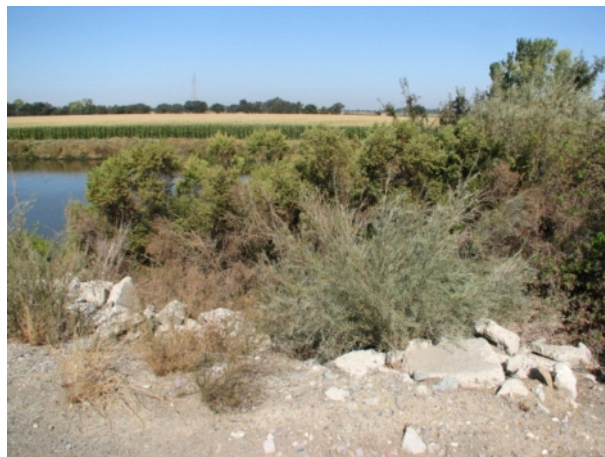
Levee Mile Report Line	20
Start Levee Mile	1.22
End Levee Mile	1.22
Location	Water Side
Category	Earthen Levee
Item	Vegetation

Photo of dense brush completely obstructing visibility and access.

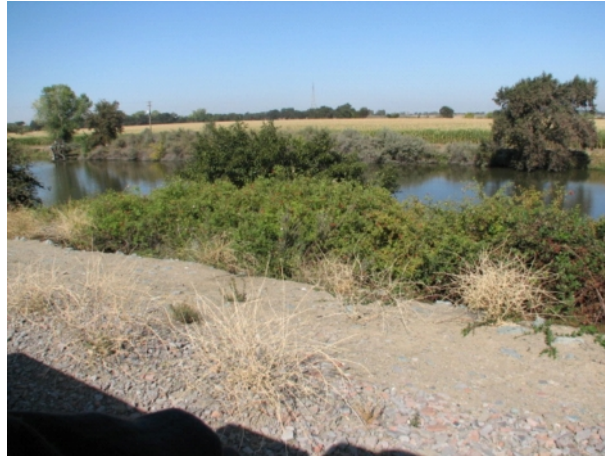
Levee Mile Report Line	22
Start Levee Mile	1.30
End Levee Mile	1.30
Location	Water Side
Category	Earthen Levee
Item	Vegetation

Dense vegetation.

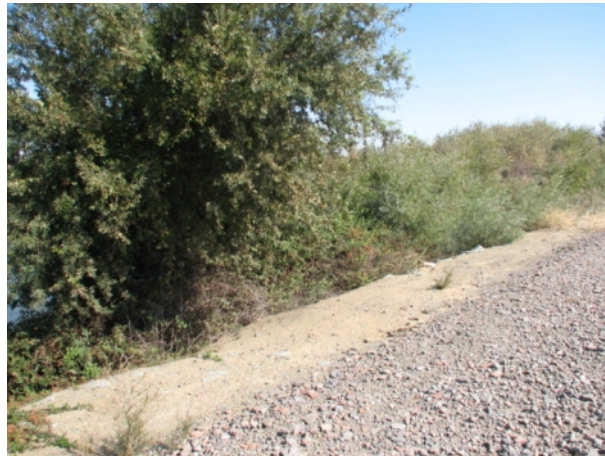
Levee Mile Report Line	23
Start Levee Mile	1.34
End Levee Mile	1.34
Location	Water Side
Category	Earthen Levee
Item	Vegetation

Dense vegetation.

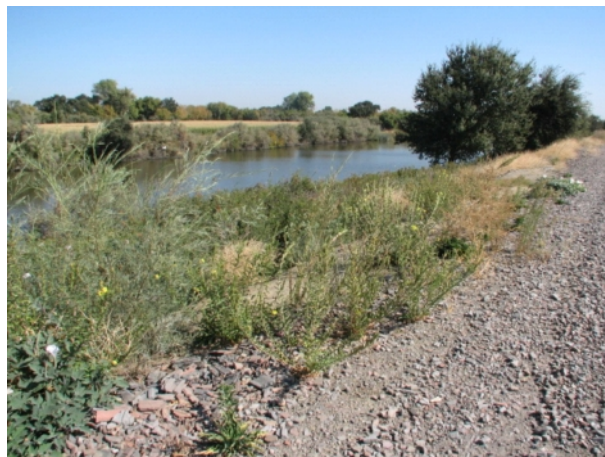
Levee Mile Report Line	25
Start Levee Mile	1.49
End Levee Mile	1.52
Location	Water Side
Category	Earthen Levee
Item	Vegetation

Photo of minimally acceptable vegetation on water side slope.

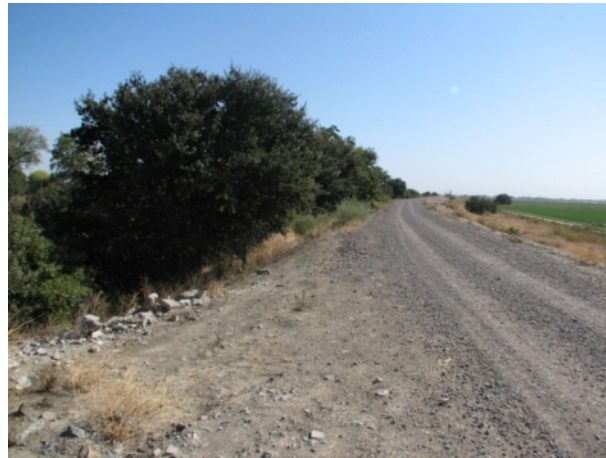
Levee Mile Report Line	29
Start Levee Mile	1.89
End Levee Mile	1.92
Location	Water Side
Category	Earthen Levee
Item	Trim / Thin Trees

Trees on waterside slope should be trimmed to allow access and visibility 20-ft from crown.

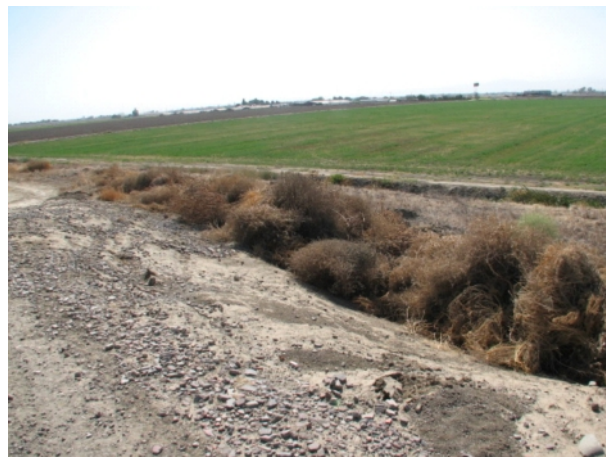
Levee Mile Report Line	33
Start Levee Mile	2.45
End Levee Mile	2.45
Location	Land Side
Category	Earthen Levee
Item	Encroachments

Photo of cleared vegetation piled on levee slope. This impedes access.

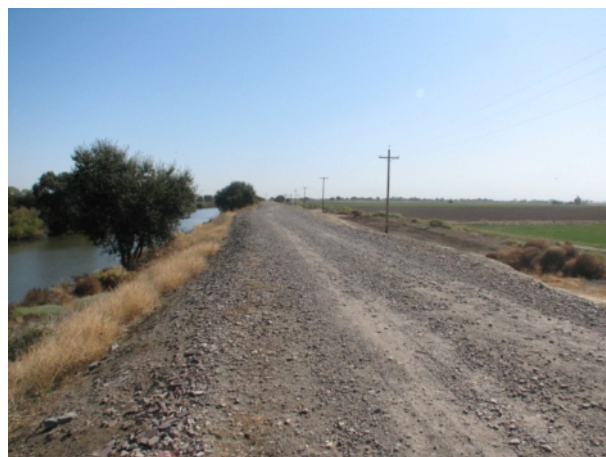
Levee Mile Report Line	34
Start Levee Mile	2.48
End Levee Mile	2.60
Location	Land Side
Category	Earthen Levee
Item	Vegetation

Photo of acceptable vegetation maintenance.

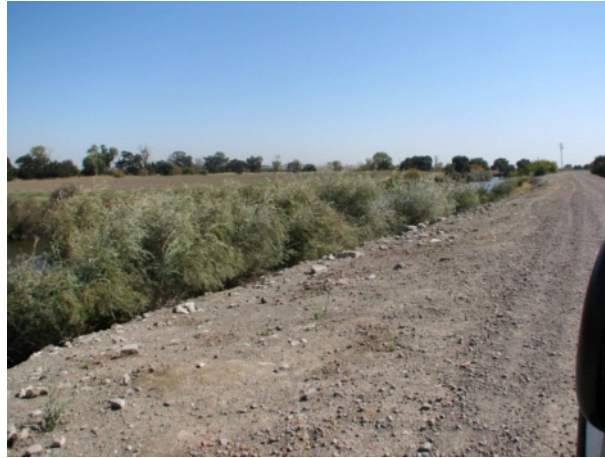
Levee Mile Report Line	36
Start Levee Mile	2.80
End Levee Mile	2.80
Location	Water Side
Category	Earthen Levee
Item	Vegetation

Photo of vegetation obstructing access and visibility on waterside slope within 20-ft of levee crown .

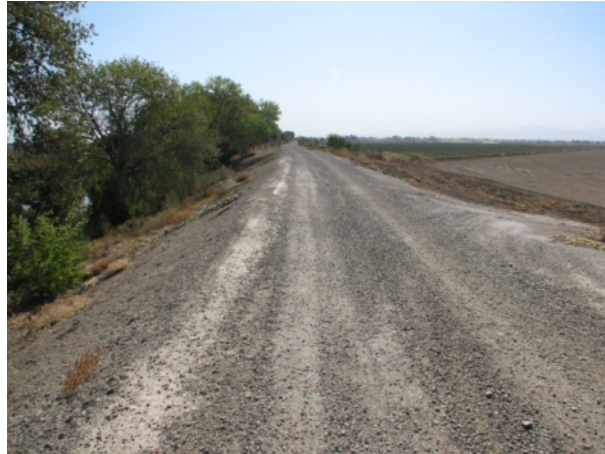
Levee Mile Report Line	40
Start Levee Mile	3.49
End Levee Mile	3.49
Location	Water Side
Category	Earthen Levee
Item	Vegetation

Photo of well maintained levee section.

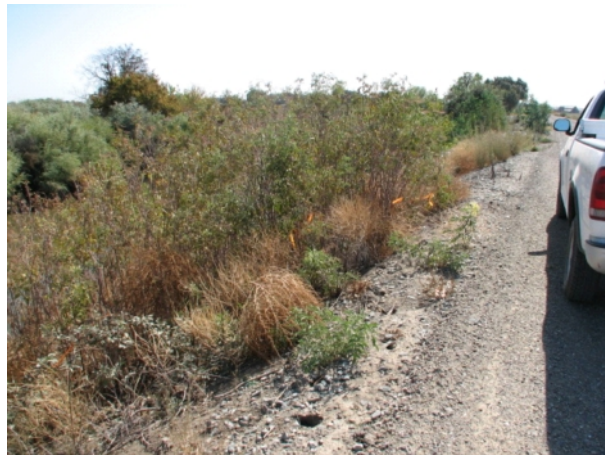
Levee Mile Report Line	42
Start Levee Mile	3.76
End Levee Mile	3.76
Location	Water Side
Category	Earthen Levee
Item	Vegetation

Flagged bushes on waterside slope.

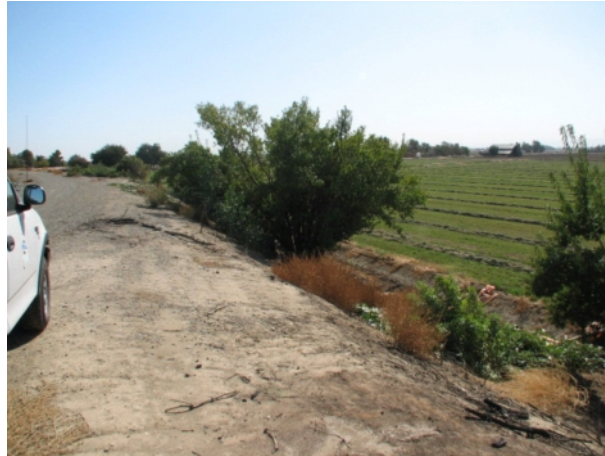
Levee Mile Report Line	44
Start Levee Mile	3.96
End Levee Mile	3.96
Location	Land Side
Category	Earthen Levee
Item	Trim / Thin Trees

Photo of trees needing trimming to allow access and visibility.

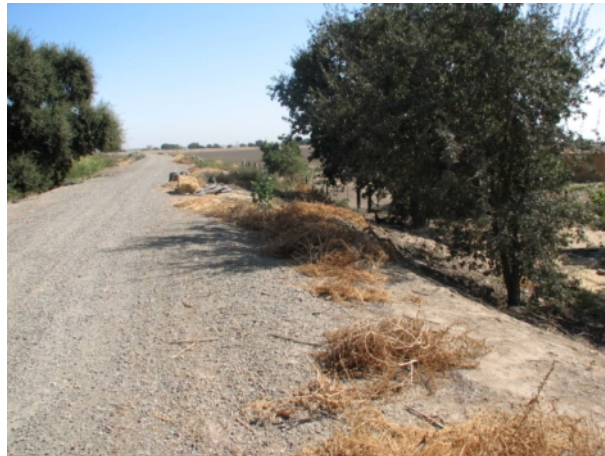
Levee Mile Report Line	47
Start Levee Mile	4.10
End Levee Mile	4.10
Location	Land Side
Category	Earthen Levee
Item	Encroachments

Photo of prunings and straw on levee crown. Crown and slopes should be clear of obstructions.

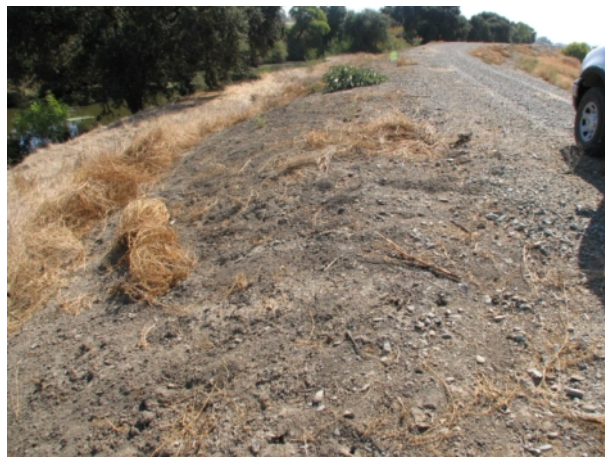
Levee Mile Report Line	50
Start Levee Mile	4.58
End Levee Mile	4.58
Location	Water Side
Category	Earthen Levee
Item	Animal Control

Small animal burrows on water side slope.

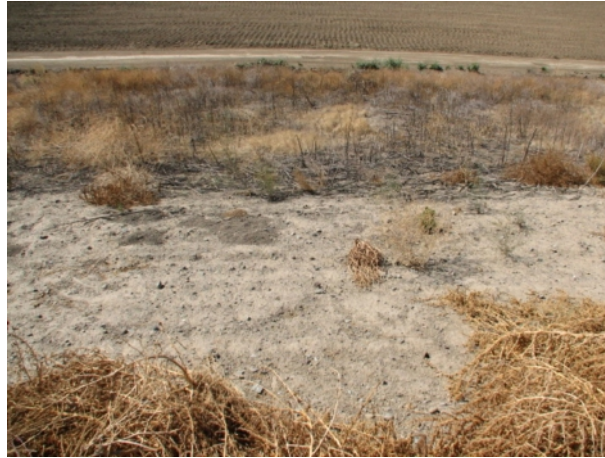
Levee Mile Report Line	52
Start Levee Mile	4.83
End Levee Mile	4.83
Location	Land Side
Category	Earthen Levee
Item	Animal Control

Animal burrows on landside slope.

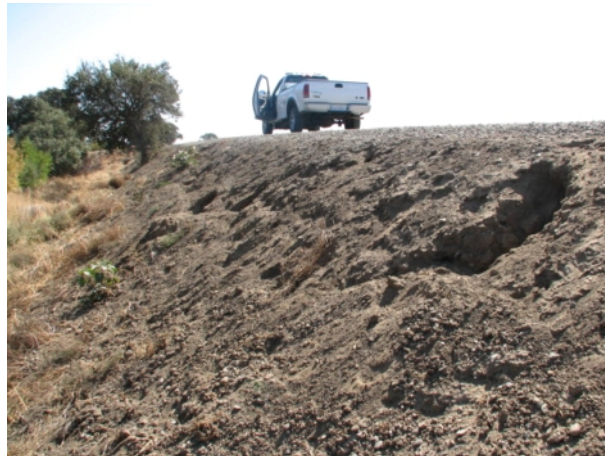
Levee Mile Report Line	55
Start Levee Mile	4.97
End Levee Mile	4.97
Location	Water Side
Category	Earthen Levee
Item	Animal Control

Photo of animal burrows on waterside slope.

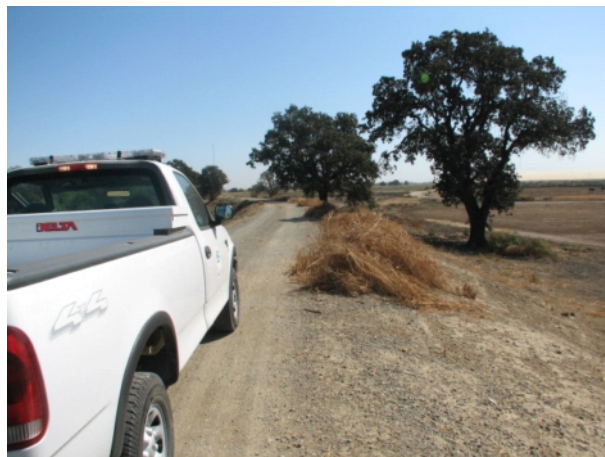
Levee Mile Report Line	56
Start Levee Mile	5.11
End Levee Mile	5.15
Location	Water Side
Category	Earthen Levee
Item	Encroachments

Photo of prunings on landside hinge point.

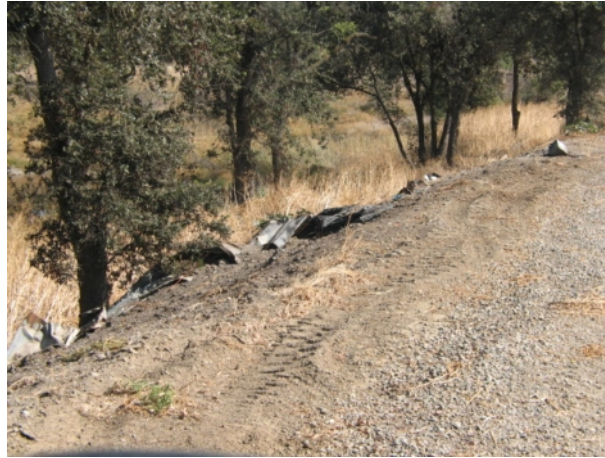
Levee Mile Report Line	59
Start Levee Mile	5.37
End Levee Mile	5.37
Location	Water Side
Category	Earthen Levee
Item	Encroachments

Photo of garbage on waterward slope.

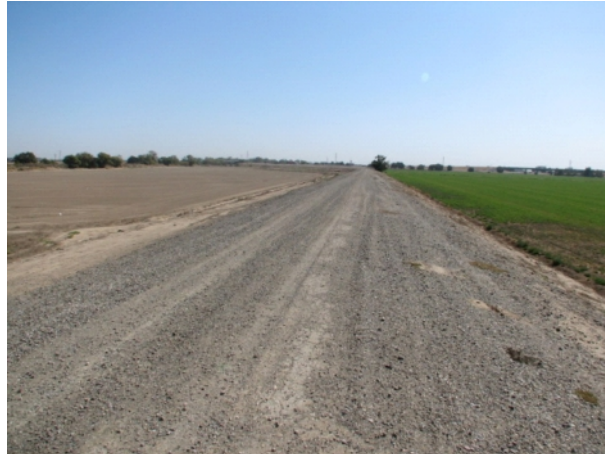
Levee Mile Report Line	61
Start Levee Mile	6.00
End Levee Mile	6.50
Location	Land Side
Category	Earthen Levee
Item	Vegetation

Photo showing cleared levee.

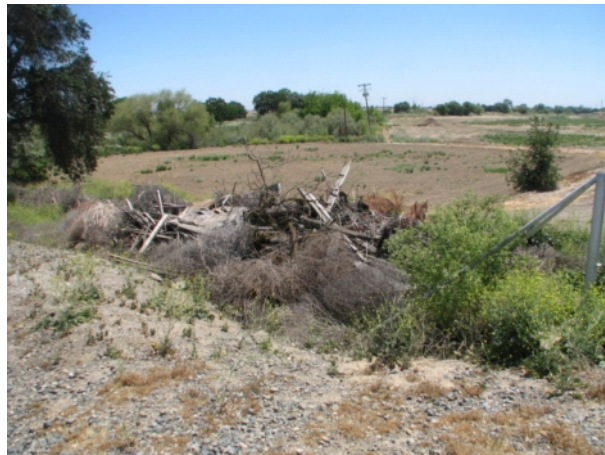
Levee Mile Report Line	62
Start Levee Mile	6.01
End Levee Mile	6.01
Location	Water Side
Category	Earthen Levee
Item	Encroachments

Garbage on waterward slope at LM 6.01 is still present during Fall 2009 inspection.

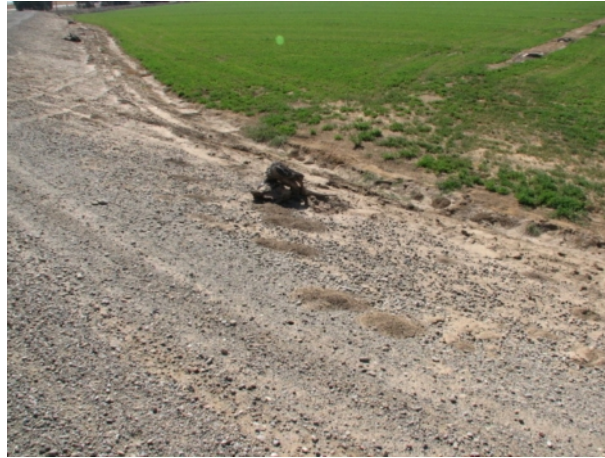
Levee Mile Report Line	63
Start Levee Mile	6.42
End Levee Mile	6.42
Location	Land Side
Category	Earthen Levee
Item	Animal Control

Photo of animal burrows near stump.
